NATIONAL ADVISORY COMMITTEE FOR AERONAUTICS

TECHNICAL NOTE

No. 1637

EFFECT OF PREIGNITION ON CYLINDER TEMPERATURES
PRESSURES, POWER OUTPUT, AND PISTON FAILURES

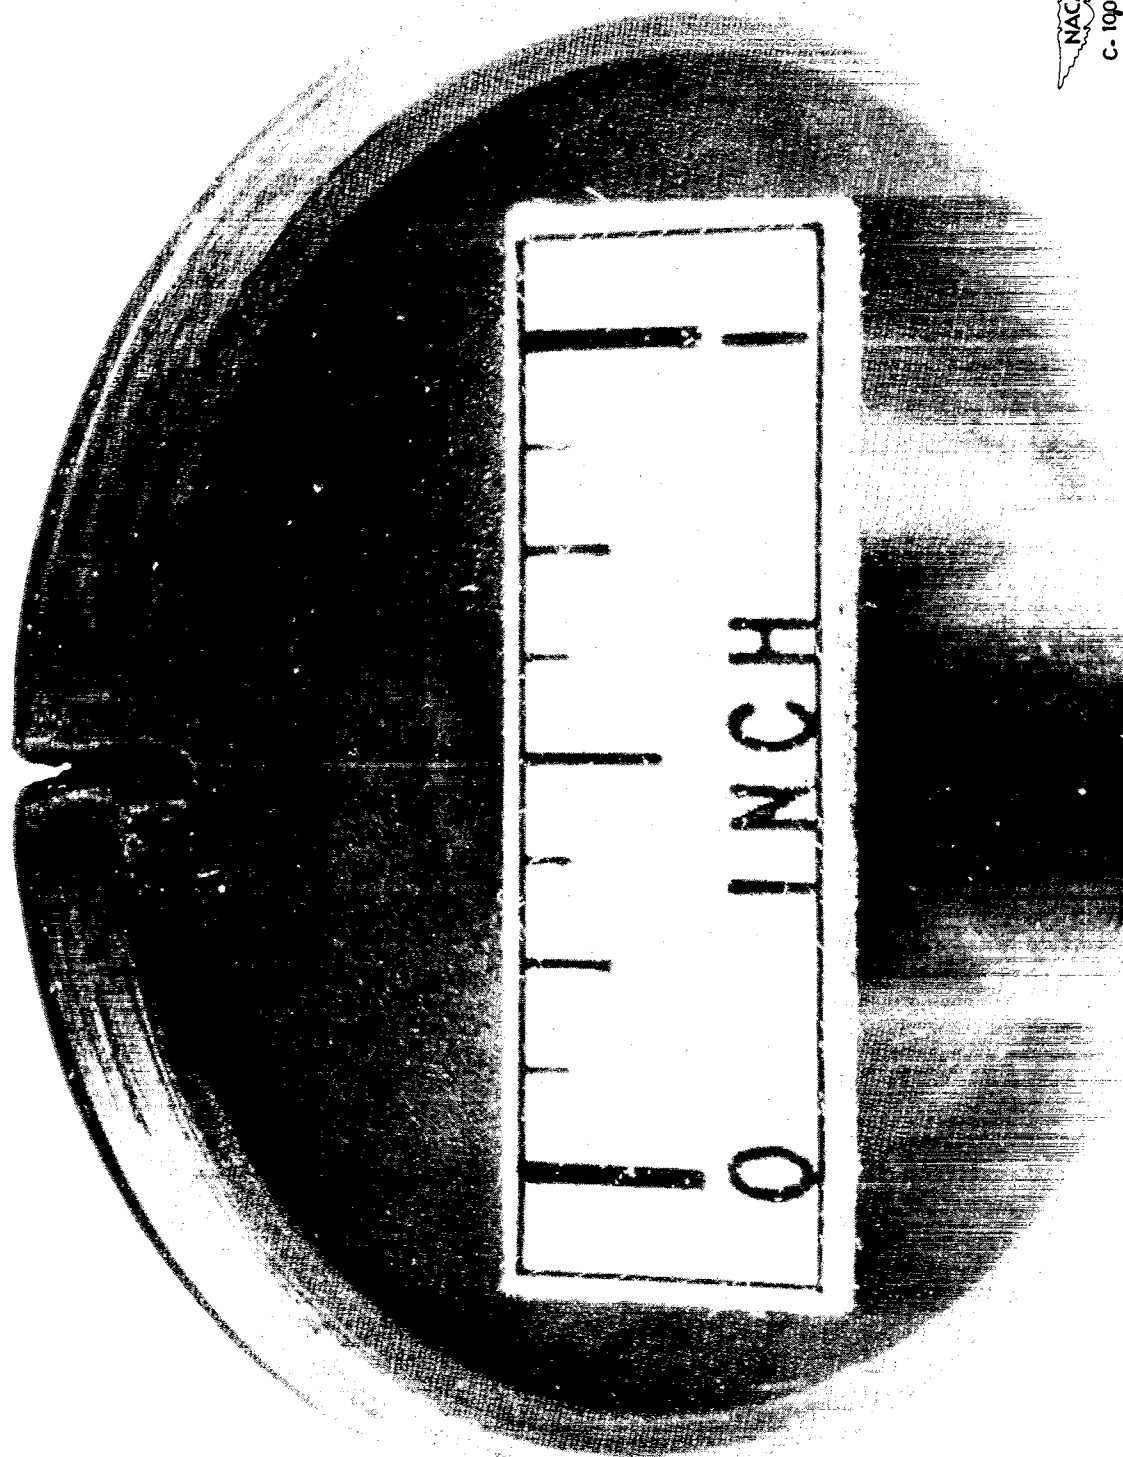
Engine difficulties experienced. - The previously mentioned runs were made with a stock piston, the diameter of which had been reduced 0.005 inch. With this added piston clearance, the only part failures encountered involved the spark plugs and the intake valves. After engine operation under some of the preignition conditions, the center electrode of the exhaust spark plug was found to be burned or melted. On two occasions one of the intake valves was found to be burned (fig. 11). Although piston-ring wear was more rapid than normal, no other failures were experienced in more than 500 preignition runs of the type discussed.

Figure 11. - Intake valve burned during preignition runs.

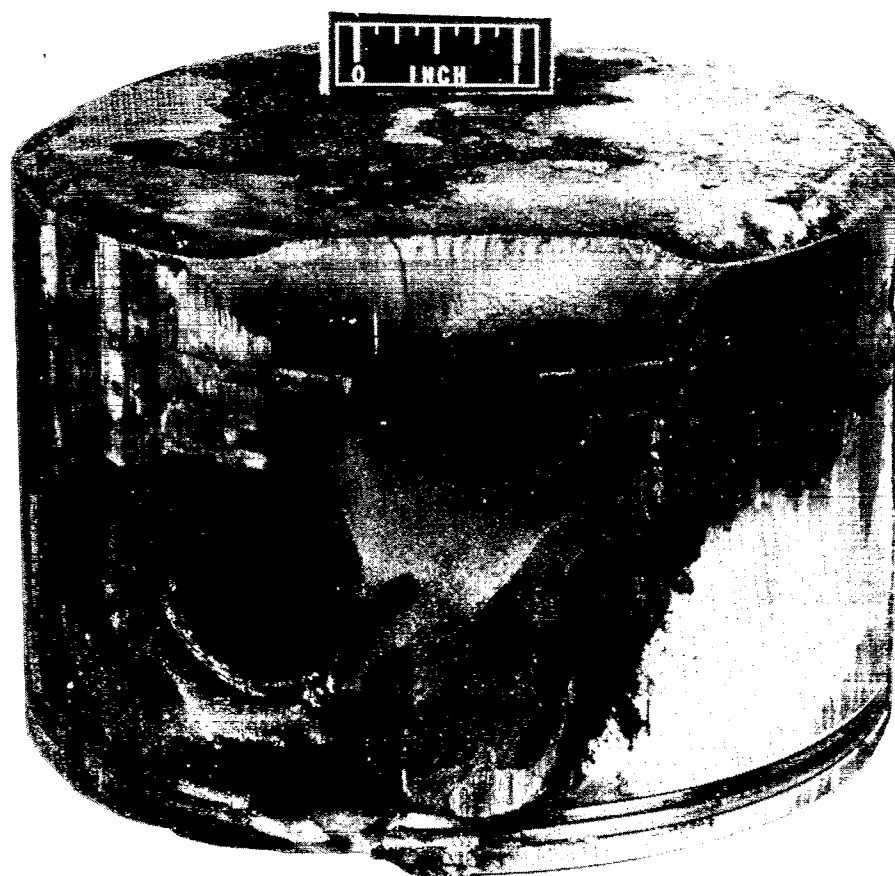
The clearance for the first run was about 0.004 inch less than the normal value (0.021 in.) for the engine. In this run, preignition caused overheating that resulted in piston seizure and consequent melting of the side (fig. 12(a)). With the normal clearance, a higher power level was necessary to cause failure but the failure was of the same nature (fig. 12(b)). The general temperature level of the piston at the time of seizure was apparently higher, however, and a small amount of local melting took place in the center of the crown. When the clearance was increased to 0.005 inch greater than normal, the failure was still a seizure with consequent melting of the side (fig. 12(c)) but more local melting took place in the center of the crown than with normal clearance. A further increase of the clearance to 0.013 inch greater than normal eliminated the seizure (fig. 12(d)) and complete failure was not experienced at the power level investigated. Slightly more severe local melting, however, took place in the center of the crown. On the basis of these runs and a number of unreported preignition investigations, when piston failure is caused by preignition the type of failure depends mainly on the clearance between the piston and the cylinder. With small clearances, the failure occurs through seizure and consequent melting of the side; whereas if the clearances are large enough, melting will probably occur wherever the piston is hottest, in the center of the crown in this instance.

(a) Clearance, 0.004-inch less than normal; imep, 271 pounds per square inch; fuel-air ratio, 0.098.

Figure 12. - Exhaust-side view of piston failures caused by preignition with various clearances between top of skirt and cylinder barrel.

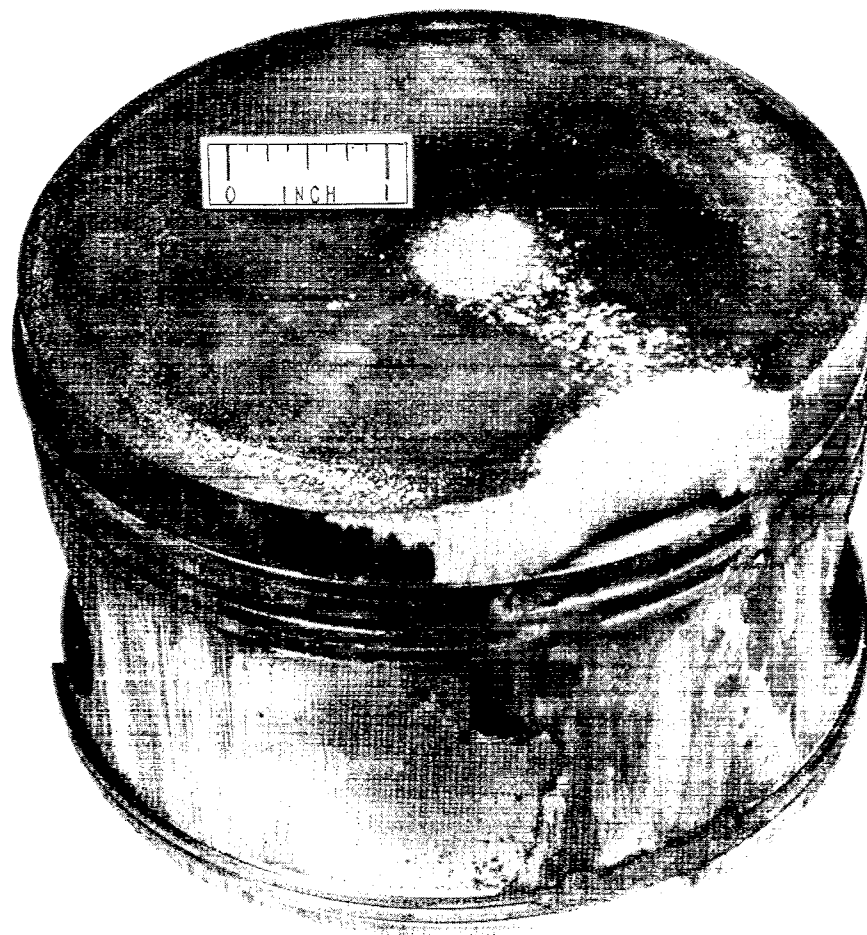
(b) Clearance, normal; imep, 364 pounds per square inch;
fuel-air ratio, 0.094.

Figure 12. - Continued. Exhaust-side view of piston failures
caused by preignition with various clearances between top
of skirt and cylinder barrel.

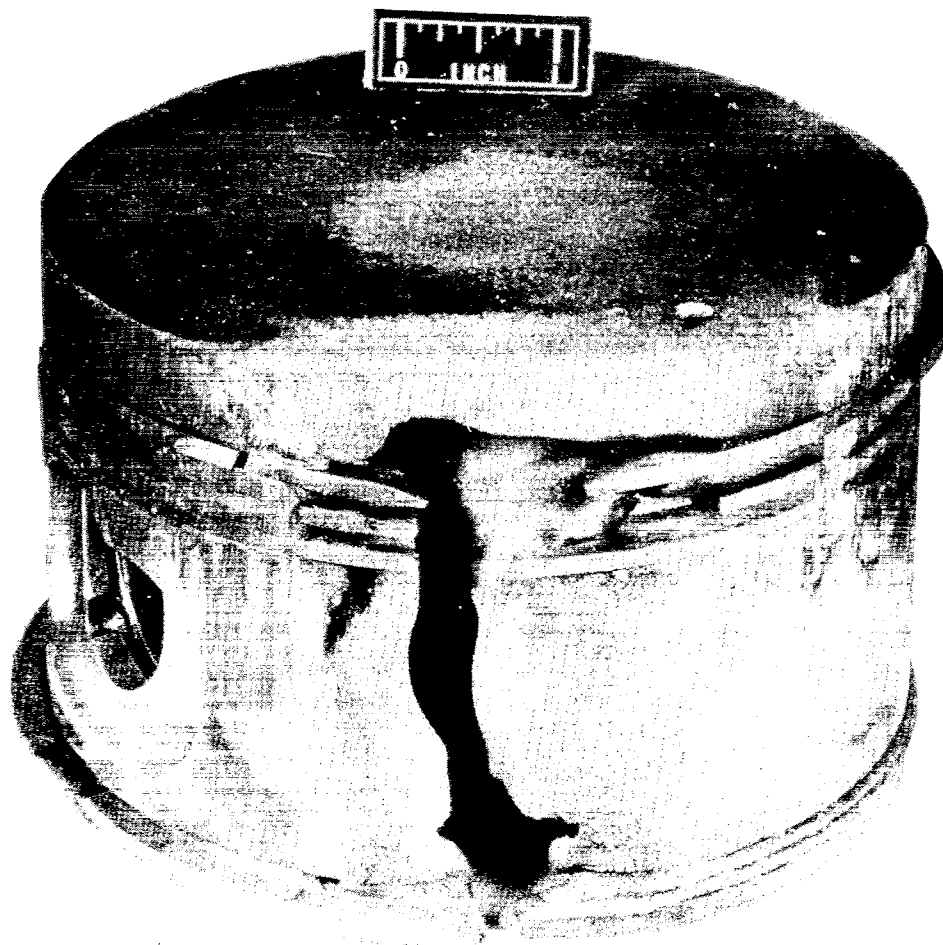
(c) Clearance, 0.005-inch greater than normal; imep, 364 pounds per square inch; fuel-air ratio, 0.094.

Figure 12. - Continued. Exhaust-side view of piston failures caused by preignition with various clearances between top of skirt and cylinder barrel.

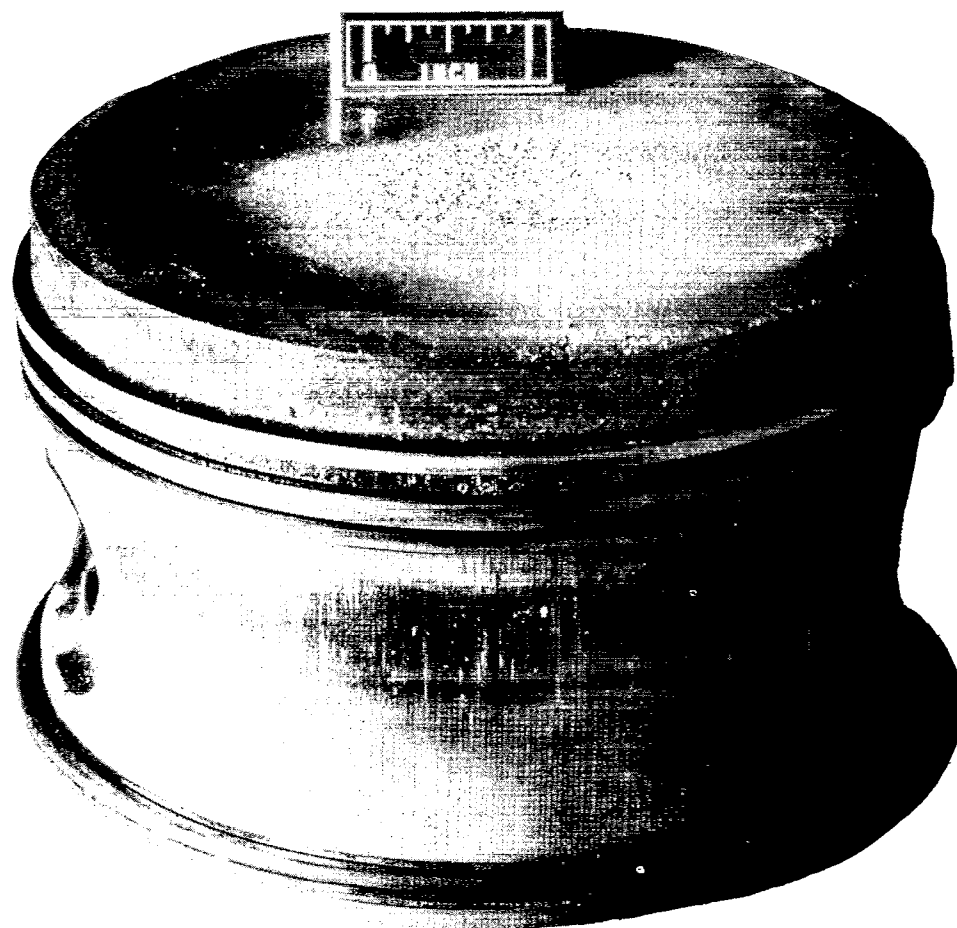
(d) clearance, 0.013-inch greater than normal; imep, 392 pounds per square inch; fuel-air ratio, 0.092.

Figure 12. - Concluded. Exhaust-side view of piston failures caused by preignition with various clearances between top of skirt and cylinder barrel.

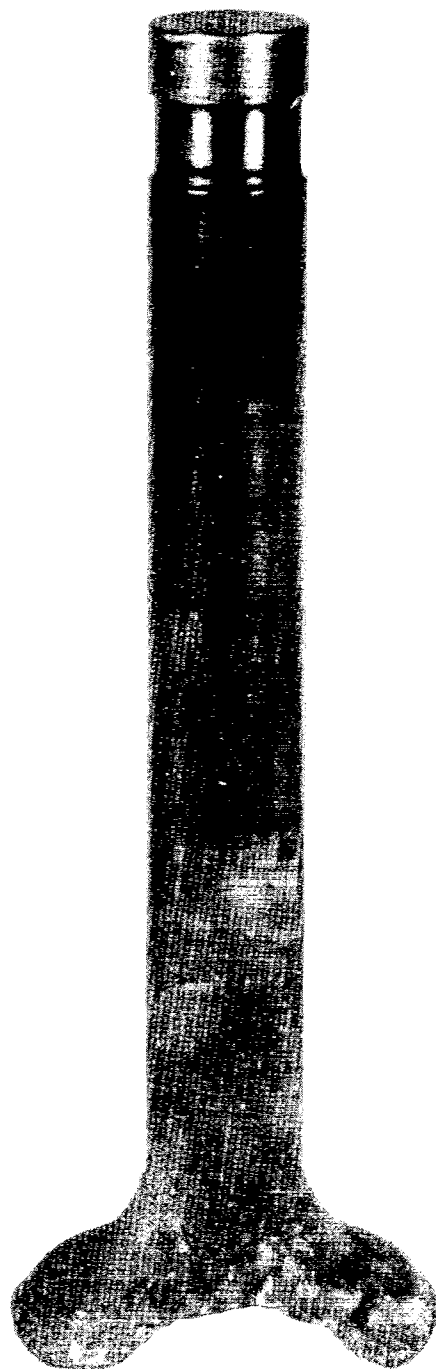
Photographs of damage to other cylinder parts that accompanied the piston failures in two of the runs are also presented. Figure 14 shows an exhaust valve that burned at the time of the piston failure shown in figure 12(b). Inasmuch as two other runs were made at more severe operating conditions without valve failure, it is felt that this failure was brought about by particles of aluminum or other substance lodging between the valve and its seat. Figure 15 shows the damage to the cylinder barrel that accompanied the piston failure shown in figure 12(c). The torching action of the hot gases burned through the barrel into the coolant passage.

Figure 14. - Damage to exhaust valve accompanying piston failure of figure 12(b).

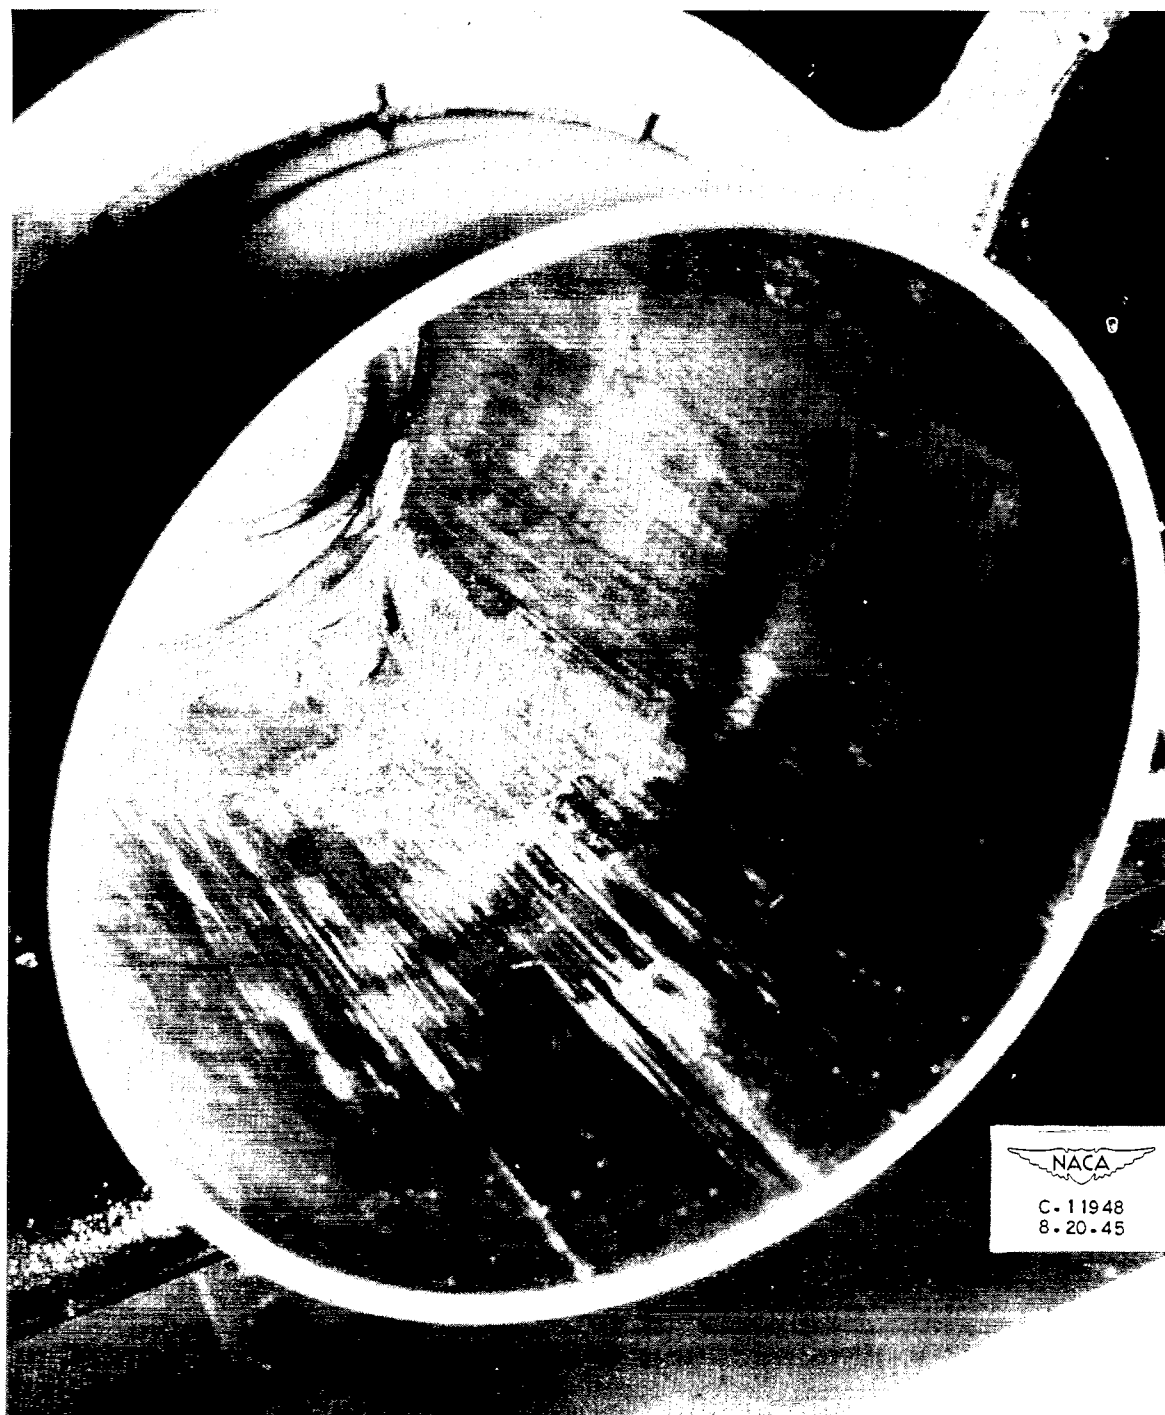
Figure 15. - Damage to cylinder barrel caused by piston failure of figure 12(c).
